Fodde, E, Watanabe, K & Fujii, Y 2007, 'Preservation of earthen sites in remote areas: The Buddhist monastery of Ajina Tepa, Tajikistan', *Conservation and Management of Archaeological Sites*, vol. 9, no. 4, pp. 194-218.  
<https://doi.org/10.1179/175355207X404188>

# **PRESERVATION OF EARTHEN SITES IN REMOTE AREAS: THE BUDDHIST MONASTERY OF AJINA TEPA, TAJIKISTAN**

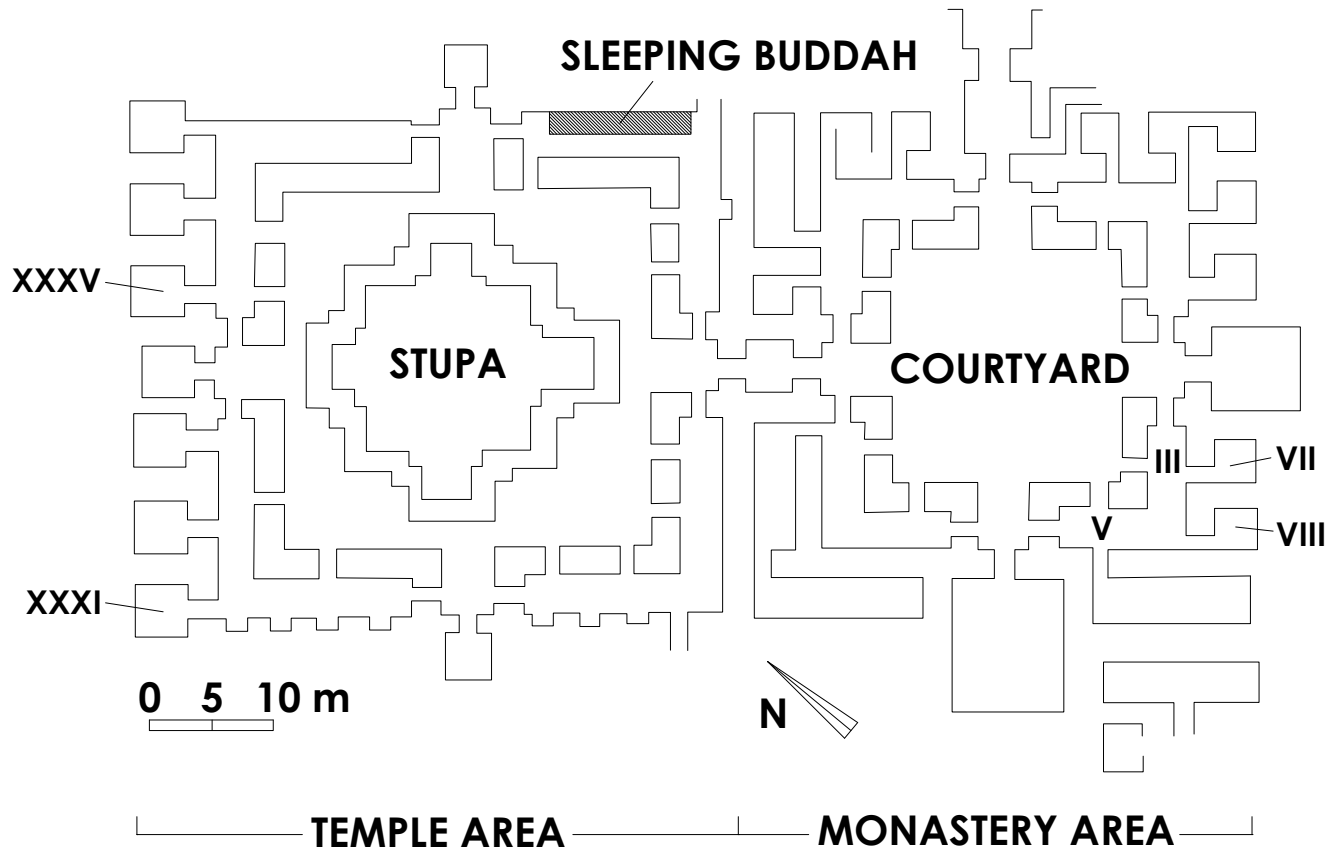
Fig 2: Schematic plan of the monastery of Ajina Tapa after Litvinskij and Zejmal (2004, 20) with numbering of points discussed in this paper. The plan shows the clear division between temple and monastery area, and the location of the sleeping Buddah (see Fig 4). The temple area is characterized by a 6m high stupa that is surrounded by four elbow-shaped passages (*īwān*). On the left hand side are a series of cellae where clay miniature versions of the stupa were found. The monastery area has a large courtyard that is surrounded by four *īwān* and by the monks rooms. The plan is characterised by thick walls (up to 2.4m) that were decorated with wall paintings and sculptures of the Buddha and bodhisattvas, now kept in the National Museum of Tajikistan. The plan of the second storey was not documented as it was not preserved.

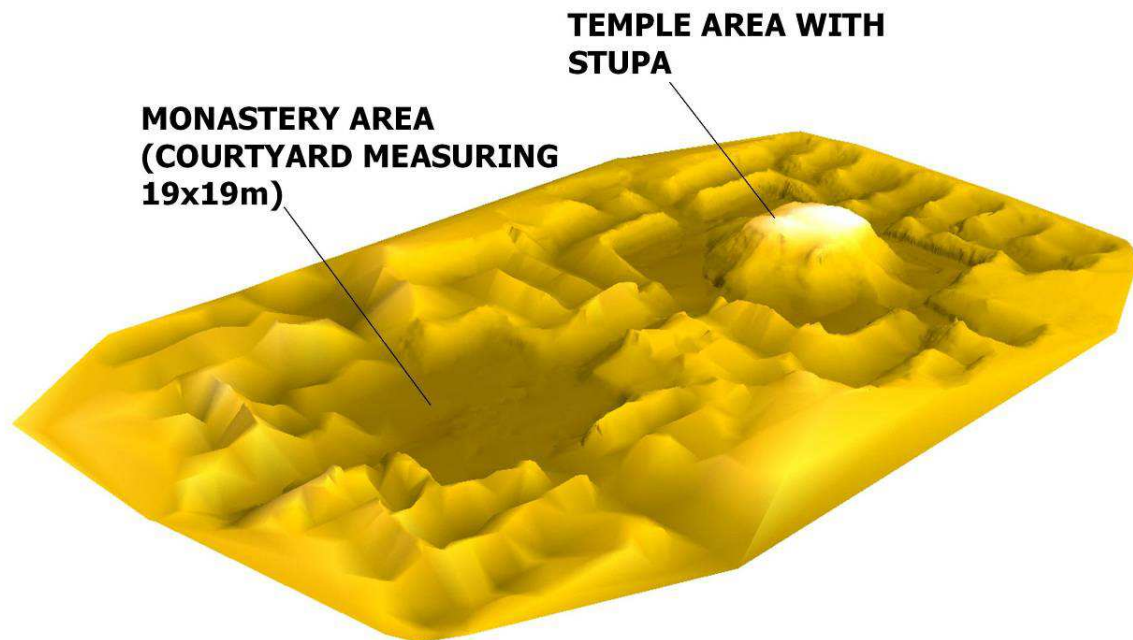
Fig 3: Three dimensional recording of the site from east showing elevated monastic area on the left (with courtyard) and temple area on the right (with elevated stupa). The overall shape of the plan is rectangular, measuring 50x100m. Picture showing documentation work in progress as carried out by Yukiyasu Fujii and Kunio Watanabe, 2007.

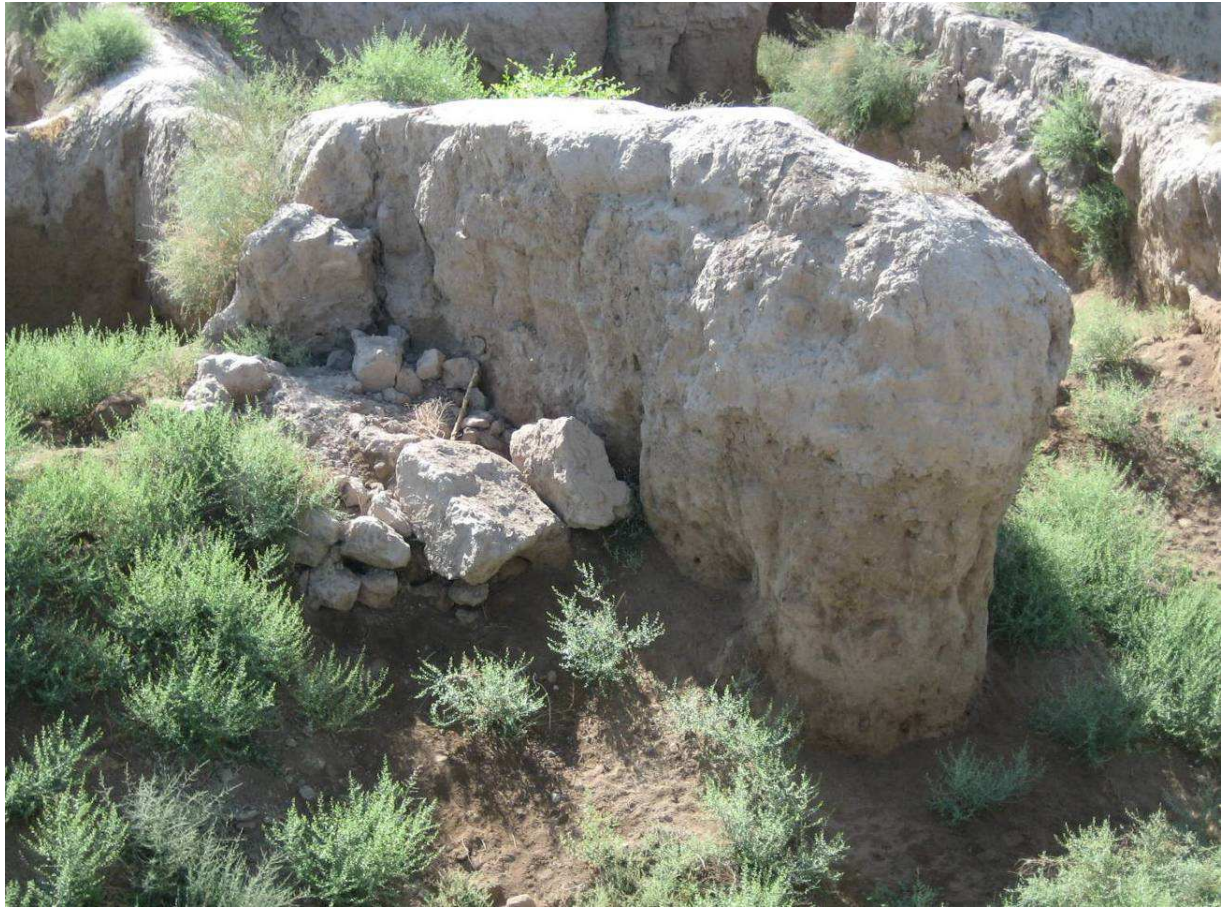
The site is characterised by a substantial amount of flora which grows between the wall structures and on top of walls (Fig 5). The vegetation is represented by succulent plants, and prickly desert grass, which vary from shallow to deep rooted. It was soon clear that one of the most urgent needs was the management of deep rooted grass that grows on top of structures. This causes serious collapse of structural parts, mainly due to the long and wide root system.

Fig 5: Growth of deep-rooted thick vegetation on and around historic earthen walls was one of the main threats for the preservation of the site (2005). Collapse of wall parts can take place when deep rooted shrubs increase in size. (Picture: Enrico Fodde).

In order to understand the influence of vegetation on the earthen structures, it was decided to select one area that was overgrown with vegetation. This was regularly cleaned from all plants and grass and photographs were taken to monitor vegetation growth. This data was compared to that of a similar neighbouring structure that was left untouched.

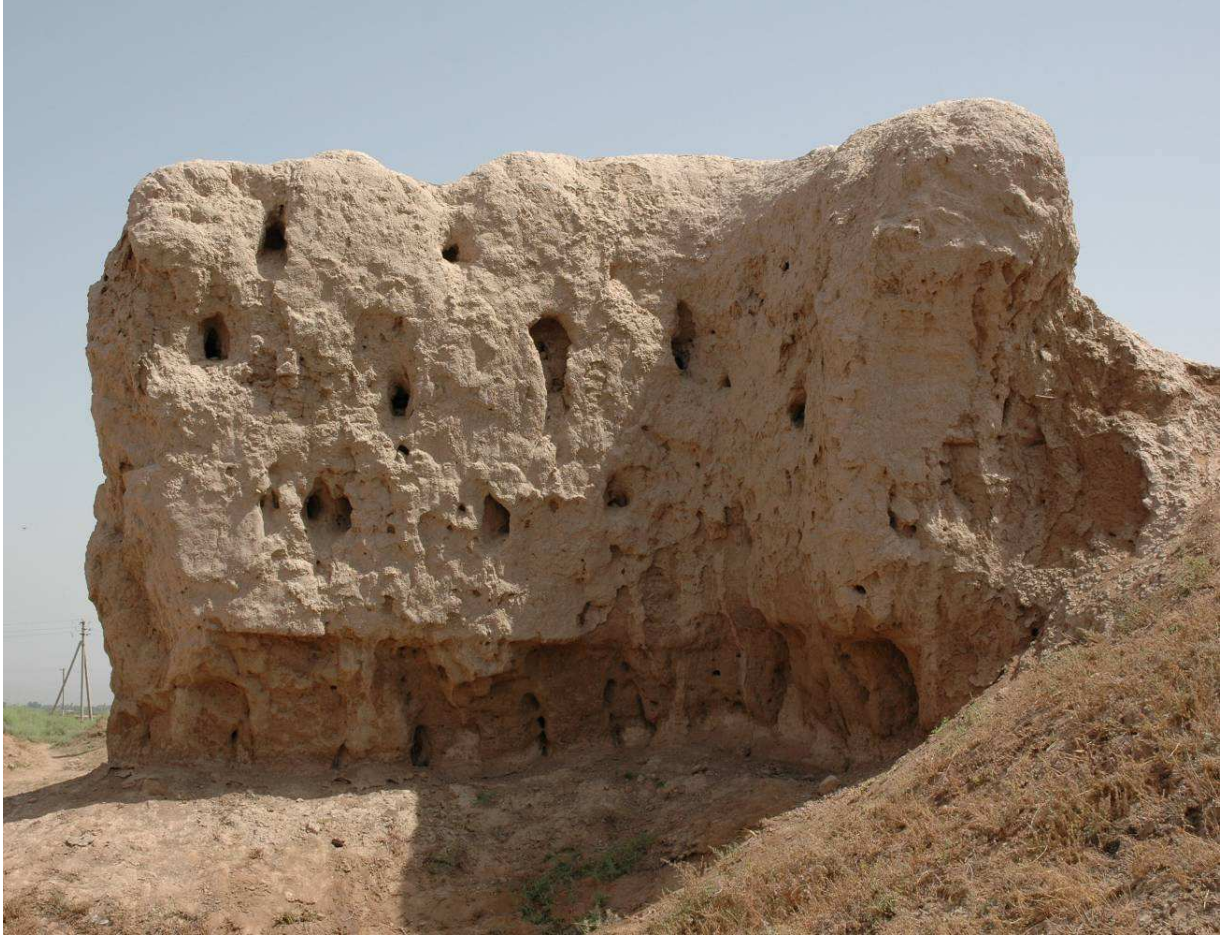
Earthen structures are mechanically eroded by water mismanagement, and by the lack of water drainage systems (Fig 6). The lack of capping or sheltering of excavated walls can cause irreversible damage. In addition, washed out soil is often collected at the base of the walls. The patterns of decay produced can be described as discrete erosion channels and general erosion due to rain washing.

Fig 6: Picture showing some of the decay patterns of the earthen walls of Ajina Tepa: coving at the wall base, erosion from top, and animal damage. (Picture: Yukiyasu Fujii).

This was carried out through photographic documentation and mapping in the topographic plan. The drainage plan is an essential tool for the removal/redirection of water away from foundations and structures for both inner and outer areas of the site. Monitoring activity should also predict the worst possible case (for example one week of repeated storms). As for drainage work, it is suggested to redirect/disperse water into small catchments, as it seems very unlikely that it could be managed otherwise.

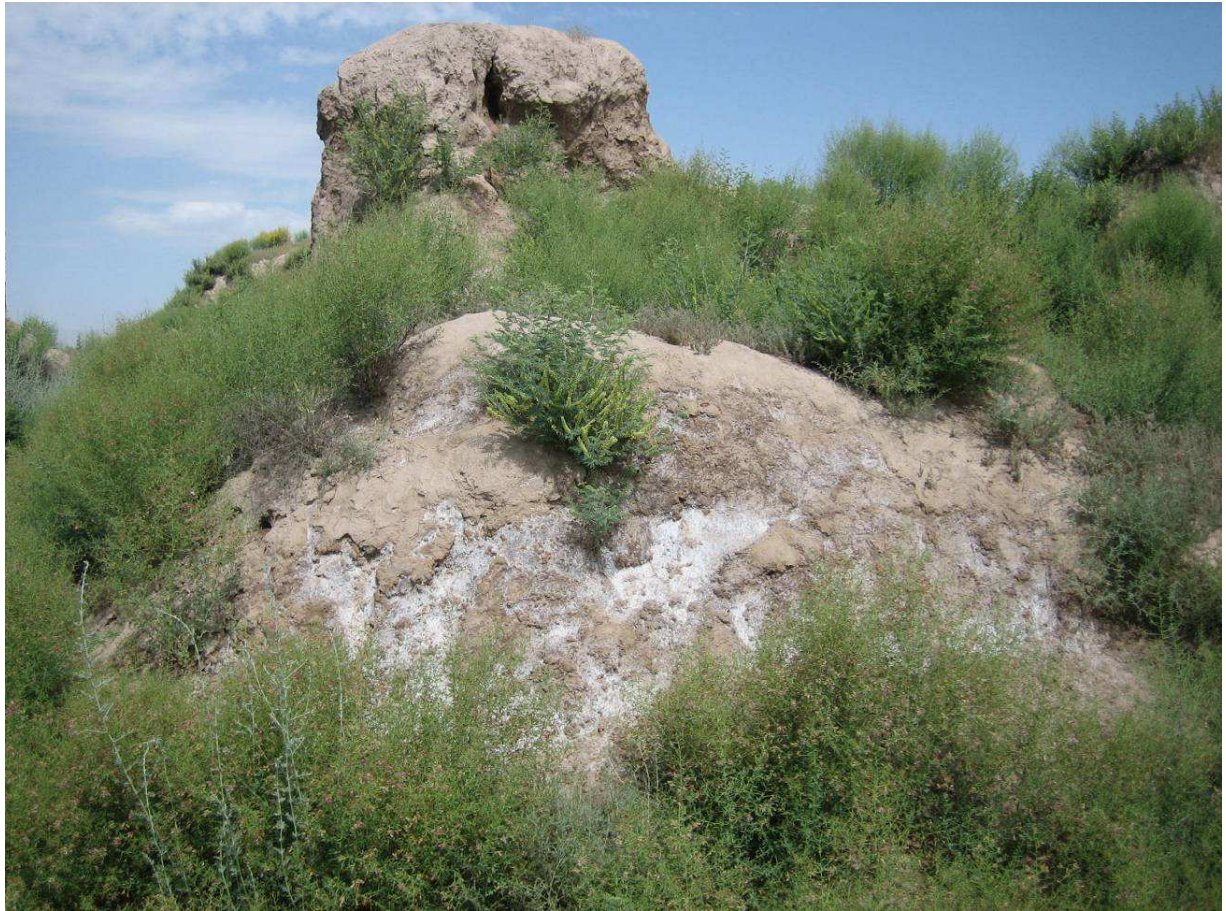
Coving (undercutting) is a typical decay symptom of earthen walls, especially when not supported by a stone plinth. It is the product of the combination of soluble salts rising from the ground which destabilises the earthen material, and of wind erosion (Figs 6 and 7). Salts can effloresce on the surface of the wall base and when this is accompanied by the combined action of wind and windblown silt, the area affected by efflorescence is easily eroded (Fodde 2007c). When this is repeated several times, the section of the wall base can become thinner and eventually lose its load bearing capacity, causing collapse. Direct inspection of several structures of the site showed that the rate of decay was high and urgent conservation work was needed.

Fig 7: Soluble salts crystallization is typical in central Asian sites. In Ajina Tepa the phenomenon is increased because the site is currently surrounded by a system of cotton fields that receive regular irrigation. The fields are about one metre higher than the floor of the site. Furthermore, an irrigation canal was built in Soviet time next to the site at a depth of about two metres from the cotton field (Picture: Enrico Fodde).

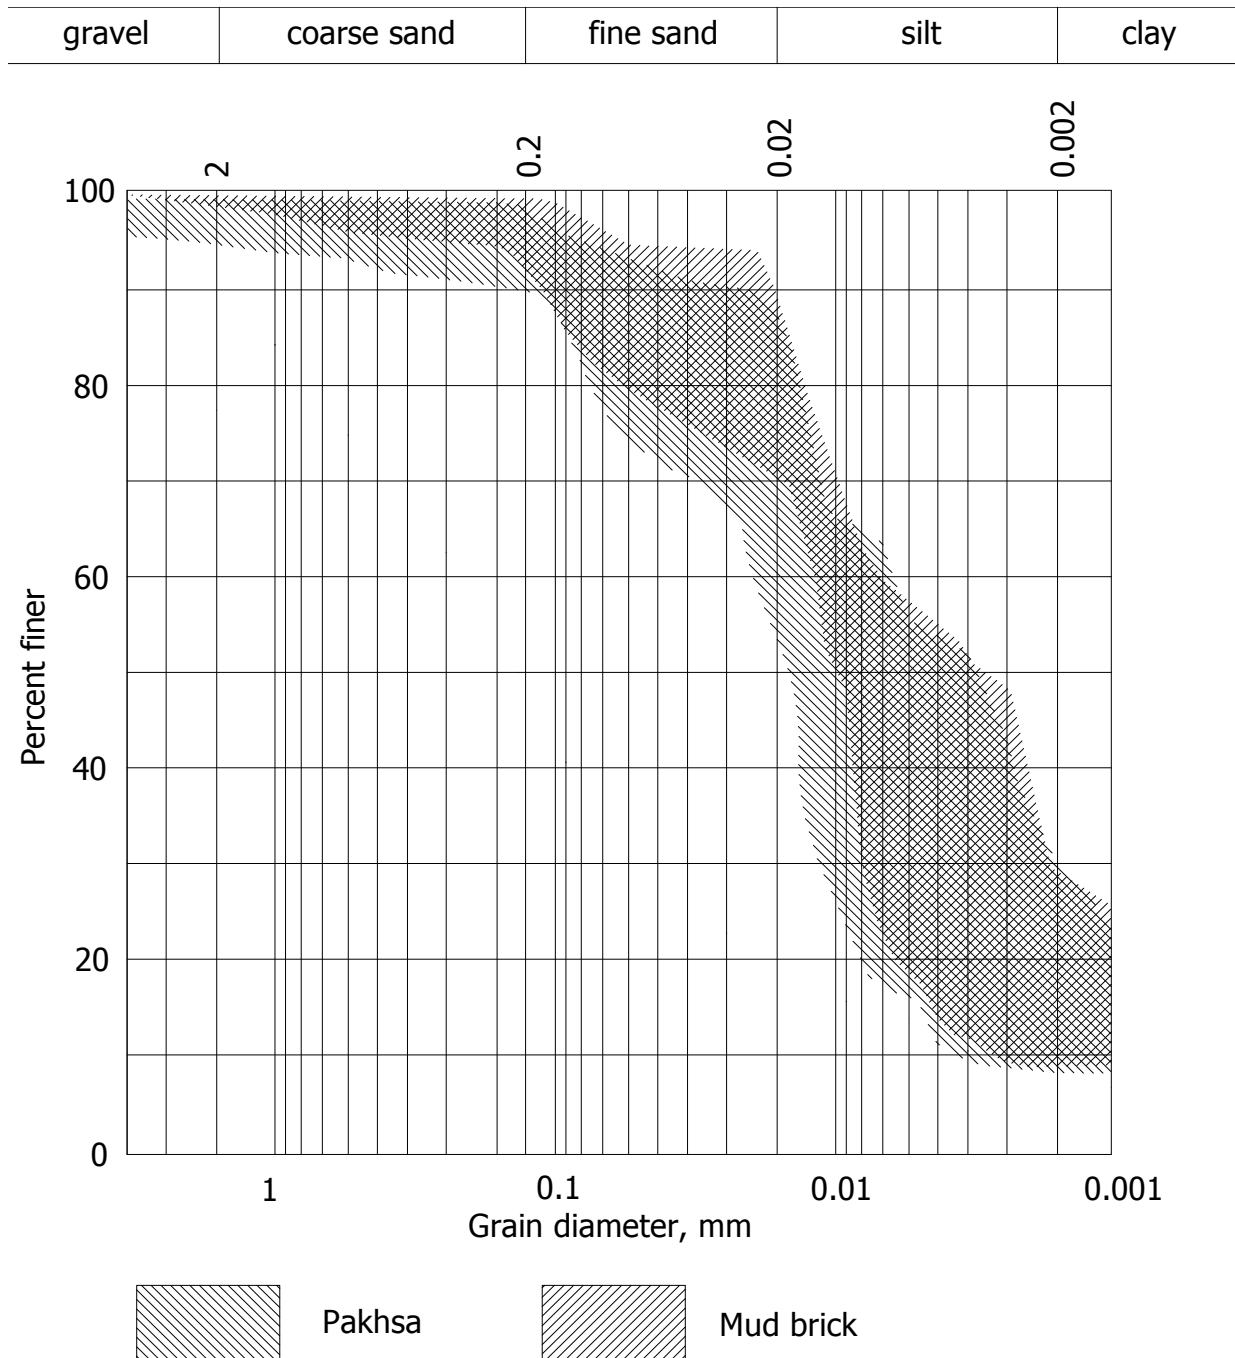
Reference areas were calculated for both mud brick and *pakhsa*, showing a slight difference between the two (Fig 8), being the latter grading envelope wider and showing the flexibility of the construction method in terms of type of soil to be used. The two reference areas were useful for comparing the granulometry curves of possible repair materials. Testing with more sophisticated equipment was carried out at Saitama University, Japan. Tests included mineralogical composition of soil, x-ray diffractometry, and soluble salts composition.

Fig 8: Diagram showing grading envelope or reference area for historic *pakhsa* and mud brick. The usefulness of a recommended zone derives from the fact that those soils which comply with it are more likely to behave satisfactorily than those which do not. The employment of this guidance zone is of great use especially for comparing it with the granulometry curves of the repair materials. Comparison between the two reference areas reveals a slight difference between range of soils employed in *pakhsa* and in mud brick. (Picture: Enrico Fodde).

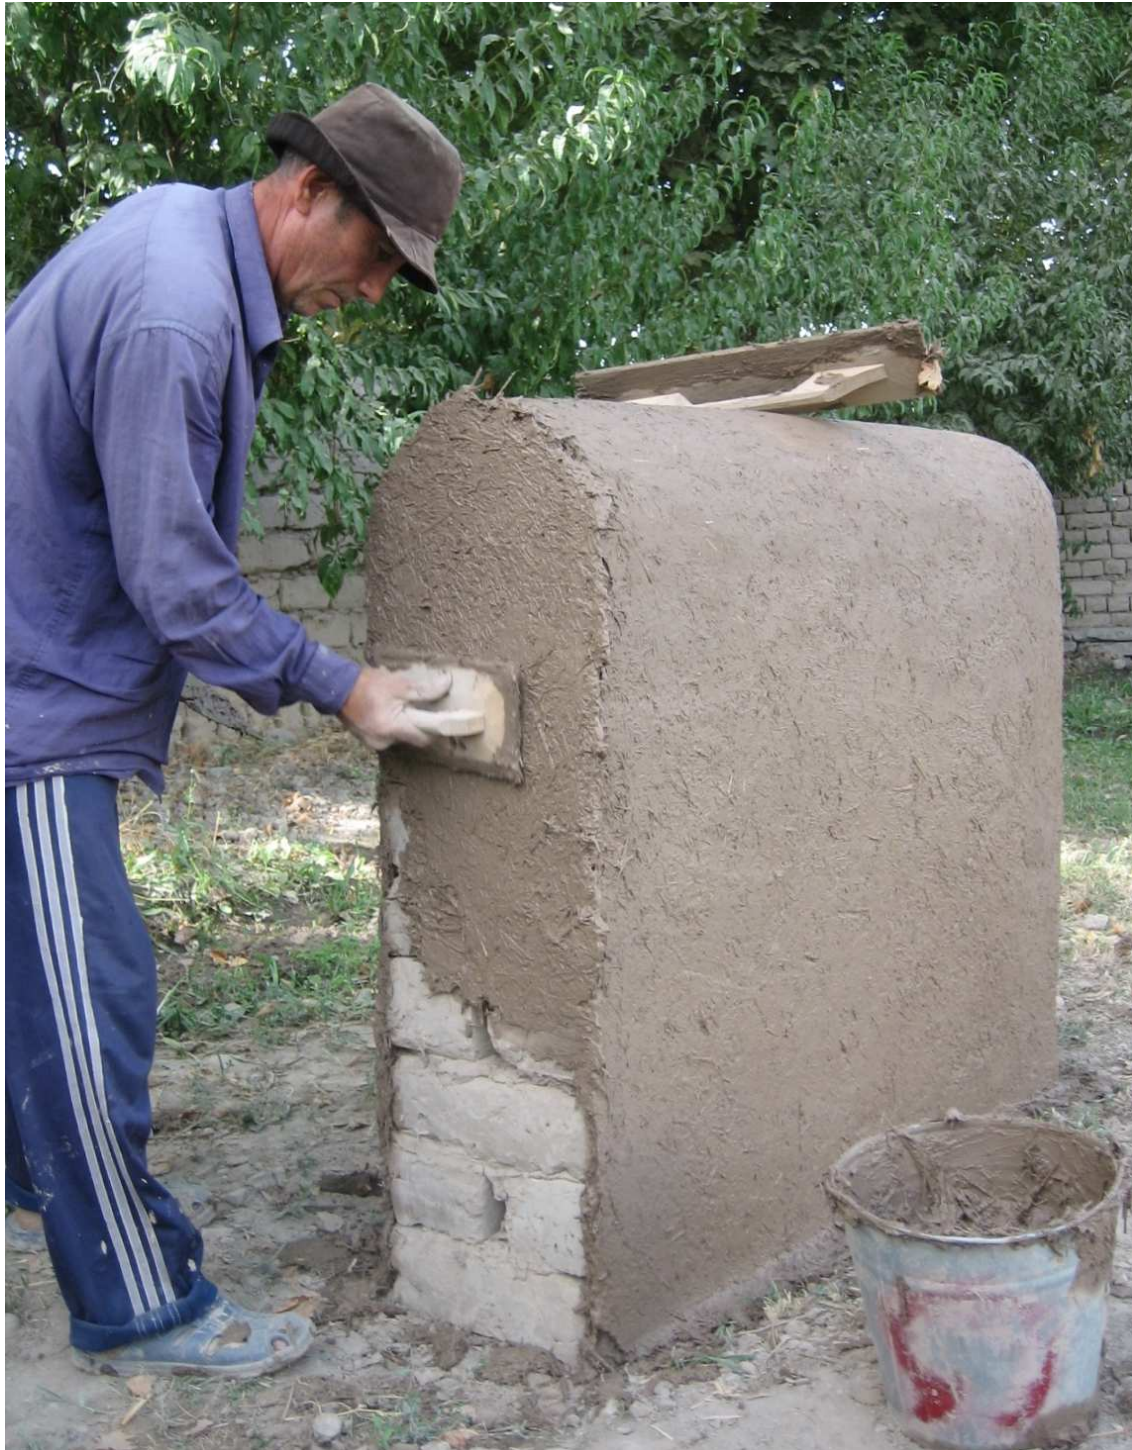
Eight test walls were built in the project house yard, following the method already carried out in Kyrgyzstan<sup>5</sup> (Fig 9). Test walls, measuring 120 x 120 x 38 cm (height, width, depth), were constructed with mud brick (measuring 34 x 16 x 10cm). The test wall construction follows the philosophical principle that suggests that testing of conservation materials should not be carried out on historic fabric. Test wall construction is dictated by the necessity of studying the best-performing material for the conservation of the site. This will be essential for testing the repair material after proper analysis in the laboratory. Monitoring of wall decay will be designed to record the following parameters: colour change, erosion, cross sections documentation, coving (undercutting), moisture, photographic documentation, extent of cracks, and weather. The data will be recorded after 3, 6, 12, and 24 months from the construction date of walls.

Fig 9: Mud brick test walls were constructed with different plasters in order to study their long term response to the elements. This technique was employed for avoiding the testing of conservation materials on the historic fabric (2006). (Picture: Enrico Fodde).

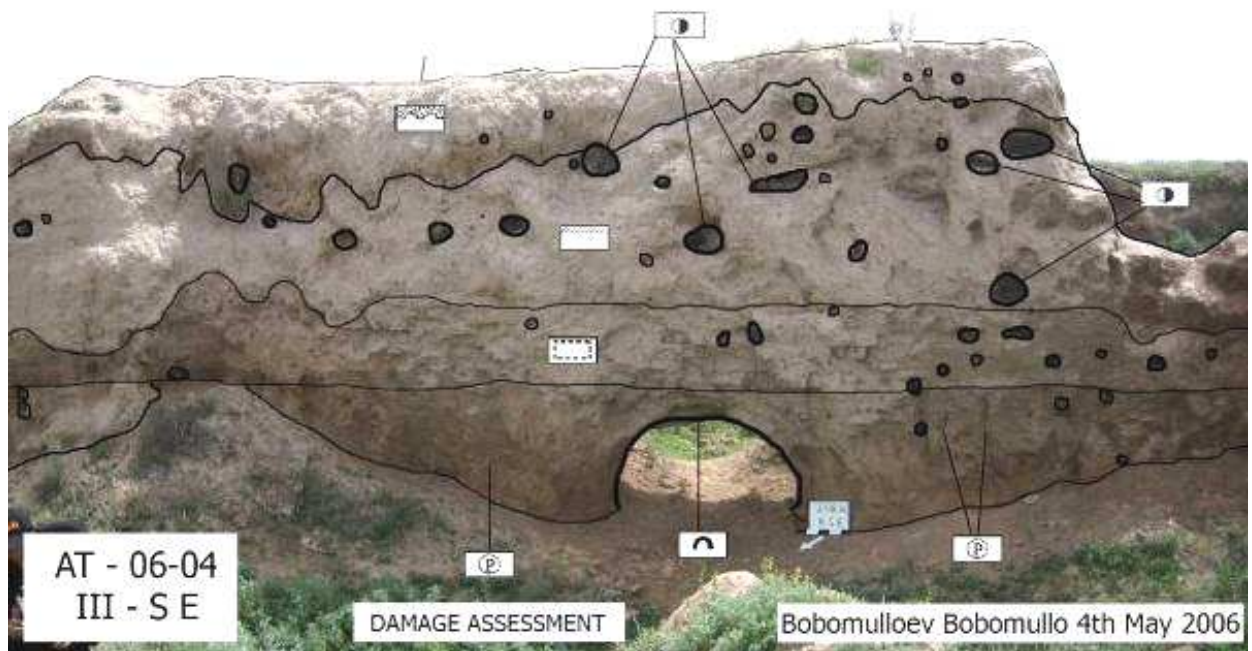
Structures were studied with drawing conventions for damage assessment, authentication, and intervention record (Fig. 10 and 11). The conventions were designed following work already carried out in other sites such as Otrar (Kazakhstan), Krasnaya Rechka (Kyrgyzstan), and Mohenjo-Daro (Pakistan) (Fodde 2007c; Fodde 2008c). This essential tool was accompanied by a sketching sheet and by a bullet-point sheet to be used as a guide for the completion of proformas. The structure of the form is based on the following subjects: description of the object, examination of historic documents (photographs, archival material, etc.), previous interventions, summary of damage report (with reference to graphic material), diagnostic summary, intervention proposal, intervention action, recommendations for future monitoring and maintenance.

Fig 11: Picture showing documentation of damage assessment (2006). Symbols refer to the drawing conventions described in the previous picture. Every picture of damage assessment was added with the following information (from left to right): date, name of the structure, and name of trainee who undertook the survey (Picture: Enrico Fodde).

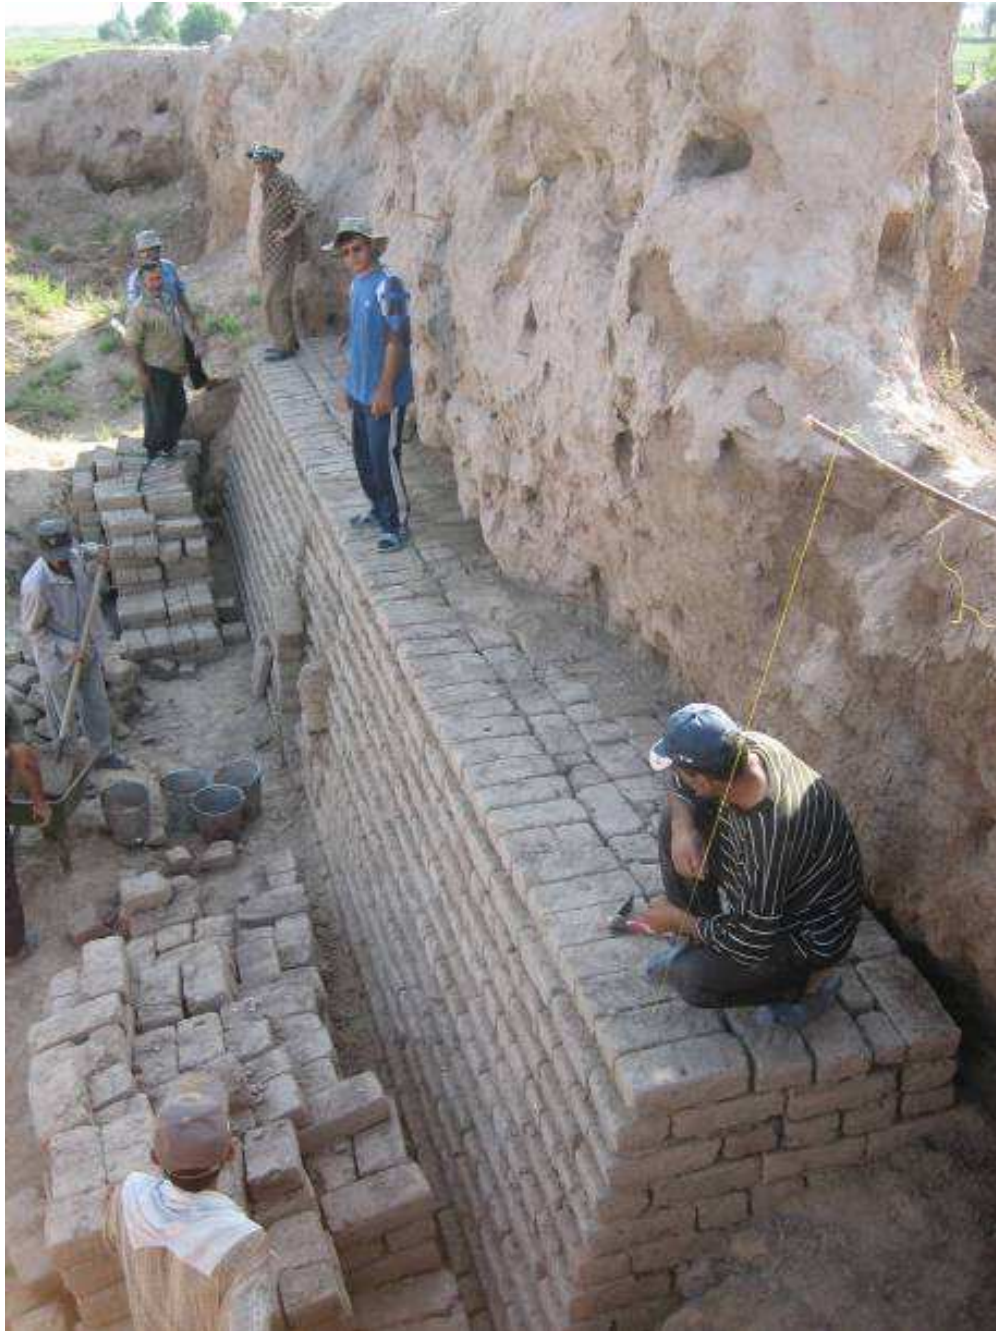
Fig 12: The most endangered walls were conserved by applying a shelter coat made of mud brick. This picture shows local master builders and labourers that were trained during the project (2007). Due to the height of some of some of the walls, shelter coats had to be made quite thick at the base. The rationale behind the design of this conservation intervention was that the historic structure would carry the minimum load and that the coat would be self supporting (Picture: Enrico Fodde).

Manufacturing of mud bricks for conservation started as soon as the selection of repair material was concluded in the field laboratory. Conservation work was concentrated in the monastery area where the most endangered structures are located (Figs. 12-17). The first area to be tackled was corridor III and V. Here archaeological cleaning was carried out under the supervision of an archaeologist. The main aim here was to consolidate structurally the wall between corridor III and VII-VIII. The shelter coat was applied following specific stages. The first was the preparation of the ground in terms of drainage so rain water would not reach the base of walls, and this was ensured by providing drainage slopes. Then a shallow trench (20cm deep) was dug along the wall and filled with a conglomerate of gravel and salts-free soil. The mix was rammed in as foundation measure, to give a solid ground on which to lay the shelter coat masonry. No geofabric was employed as a separation layer between the historic structures and the shelter coat because in Tajikistan there is a strong bias against such material: it is felt that it could emphasize rising damp and that its future use would be too expensive for any local project. Hence the construction of the shelter coat followed without separation layer; however, the mud bricks employed are clearly legible as a modern intervention. Filling of the gap between the mud brick skin and the historic fabric was carried out with dry soil. Plastering of the encapsulation with a mix of soil and straw then followed. In some cases windows were left so that to expose the historic fabric as a didactical approach to the shelter coating. This method was successfully employed in another UNESCO project: 'Preservation of Silk Roads Sites in the Upper Chuy Valley in Kyrgyzstan' (Fodde 2008b).

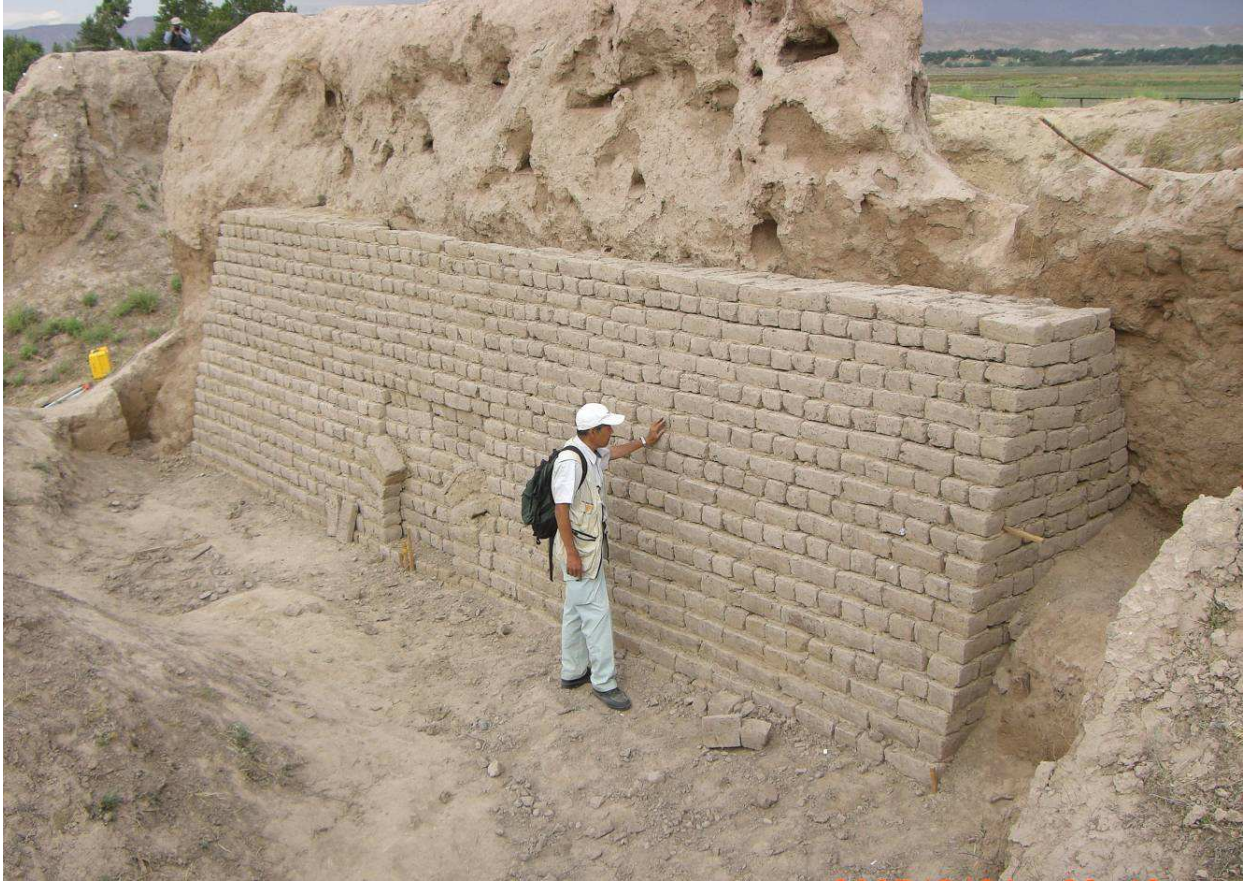
Fig 13: Picture showing work progress relatively to Figs 11 and 12. (Picture: Kunio Watanabe).

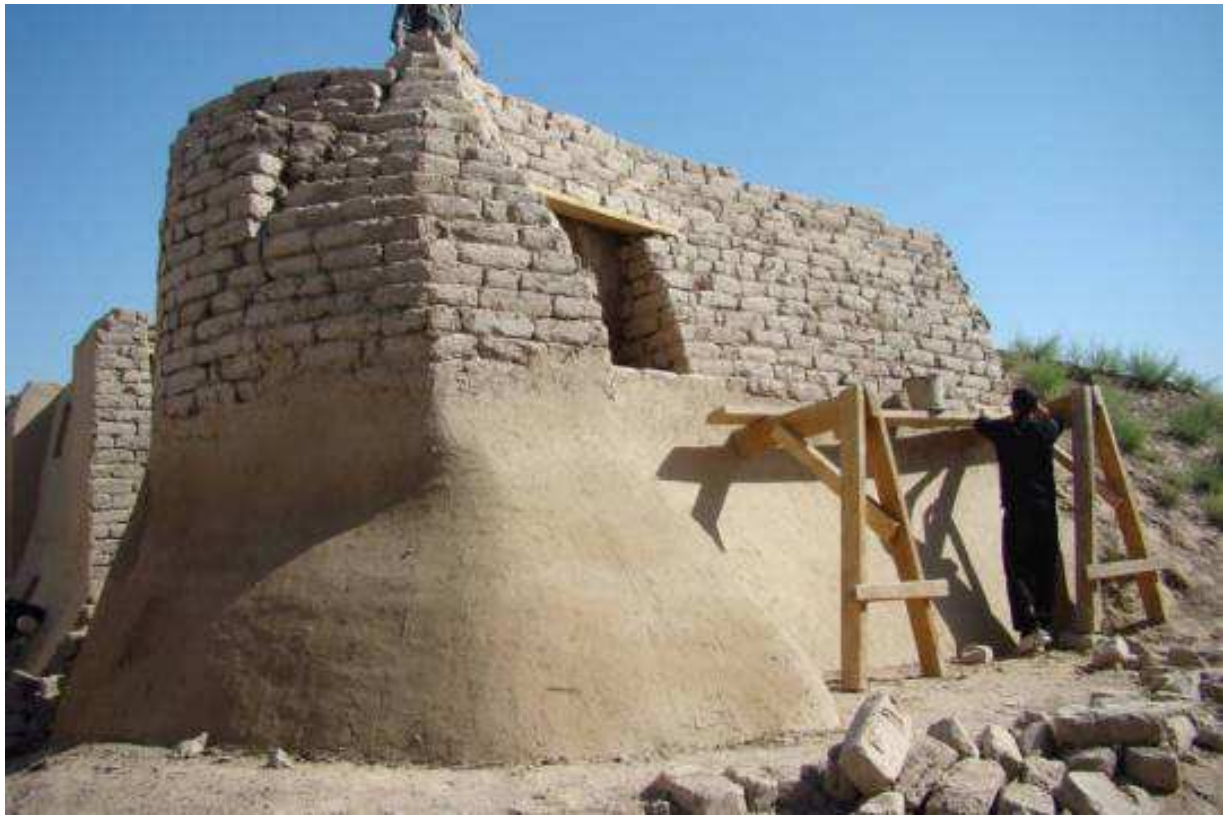
Fig 14: Shelter coating followed the morphology of the earthen walls and in some cases windows were left to expose the original fabric a didactic guide to the work done. (Picture: Malika Budanaeva, 2007).

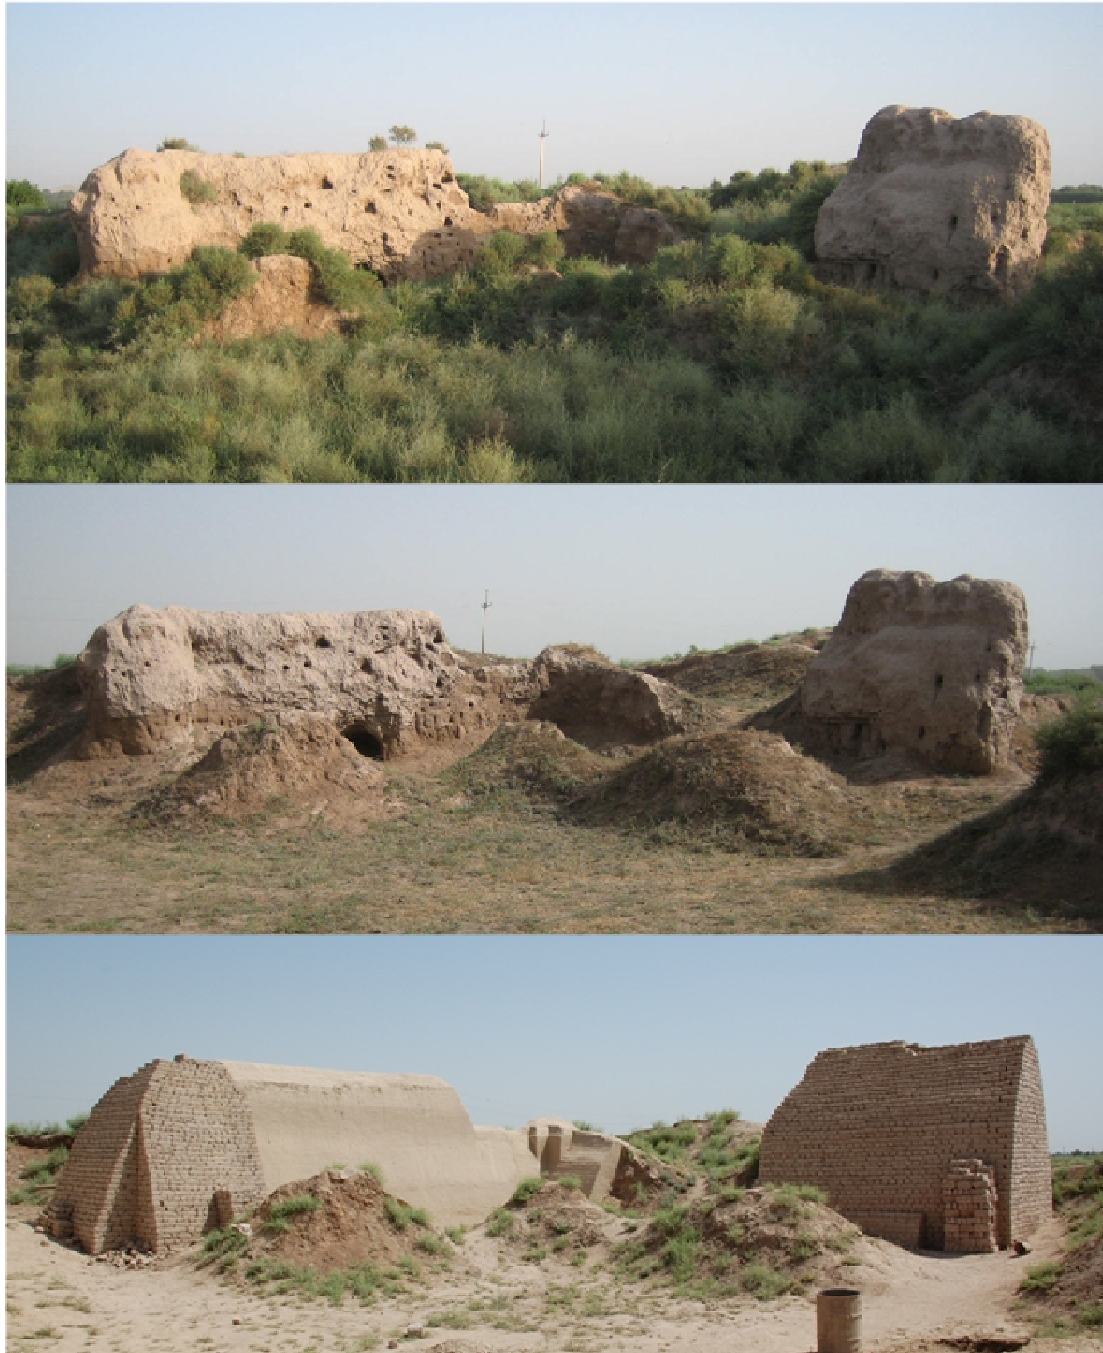
Figs 15, 16, 17: View of areas III and V from the monastery courtyard. Illustrations showing sequence of encapsulation work: portion of the monastery before cleaning of grass, after cleaning, and after application of shelter coating (2005-2008). The tall wall on the left hand side is the one illustrated in Figs 11, 12, and 13. (Pictures 15 and 16: Enrico Fodde. Picture 17: Yuri Peshkov).

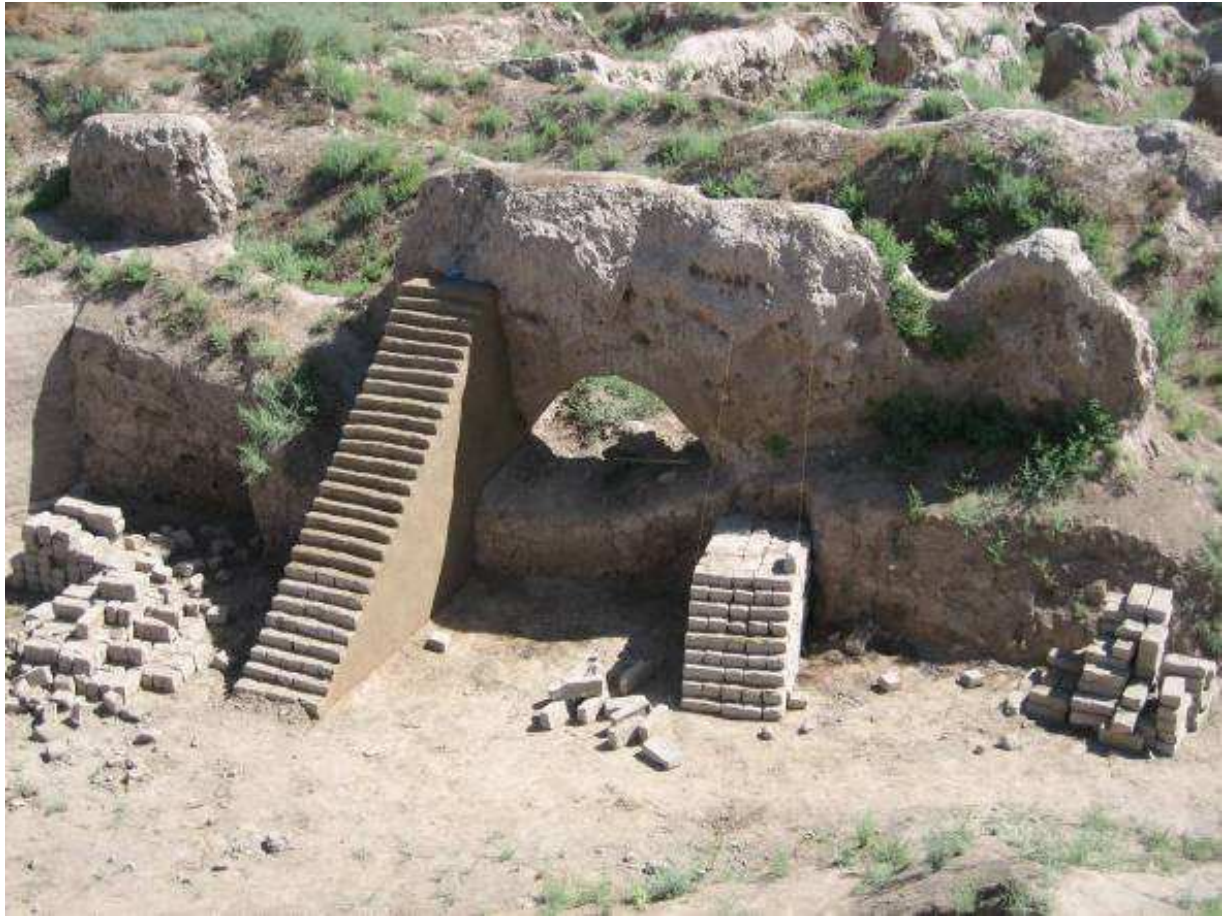
Fig 18: Structural consolidation of leaning walls was undertaken with thick mud brick buttresses that have the advantage of being reversible and easily readable as a new intervention (2006). Illustration showing work in progress (Picture: Enrico Fodde).

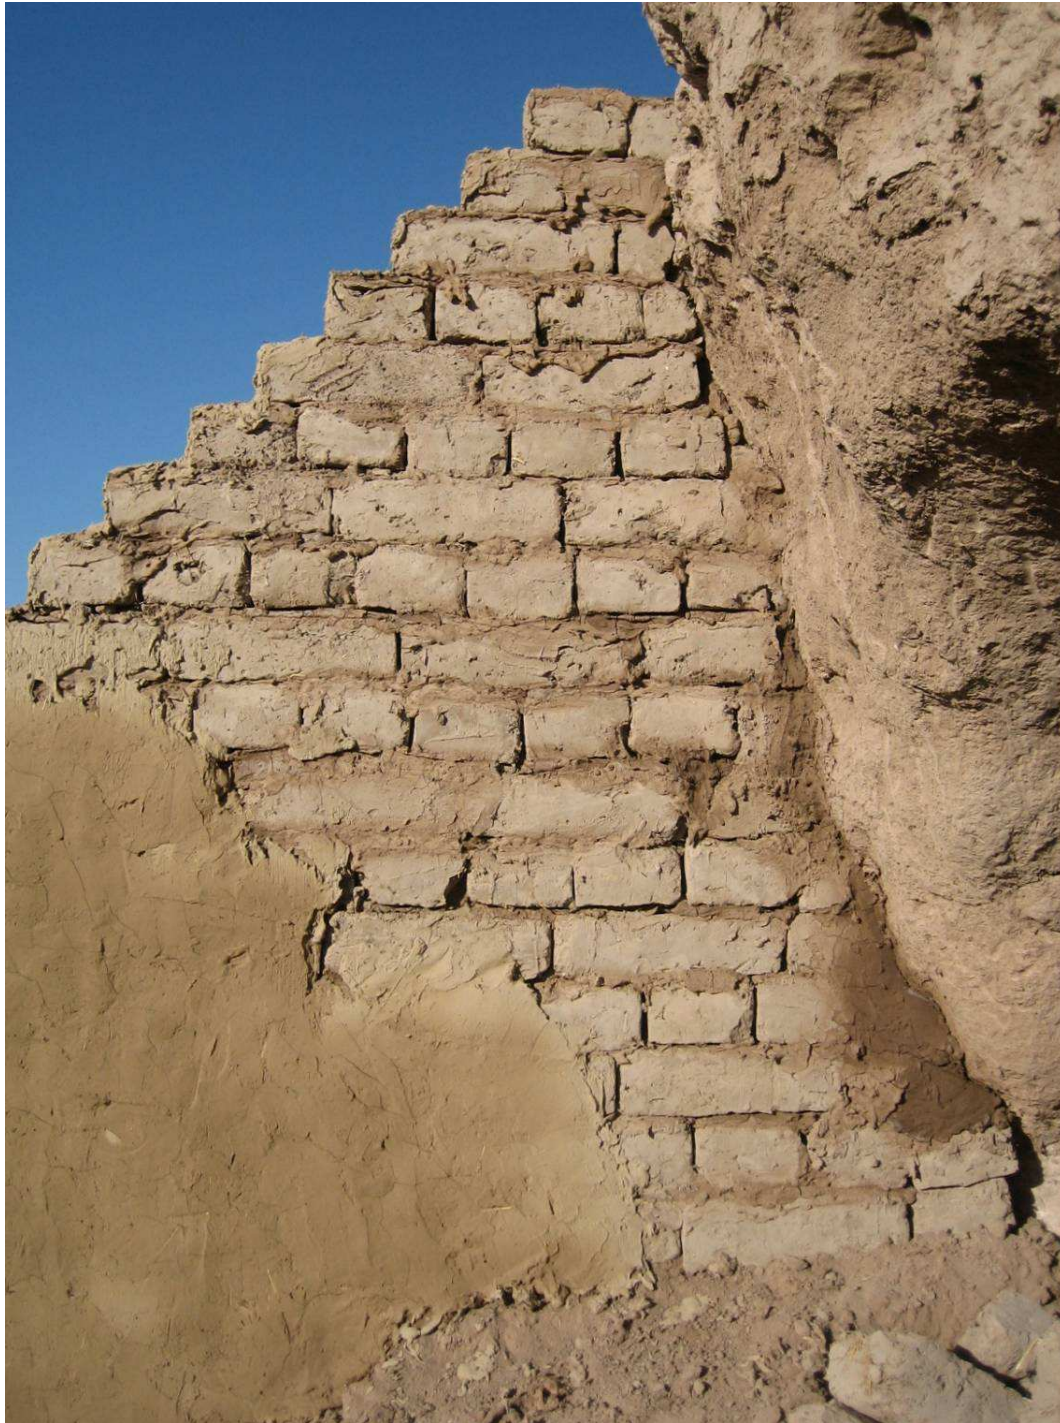
Fig 19: Detail of previous picture showing relationship between mud brick buttress (under construction) and historic earthen wall (right). In order to have reversible interventions the buttress was built without inserting any bricks into the historic fabric, but by making sure that the connection was well packed with dry soil (2006). (Picture: Enrico Fodde).
